Annual Inspection

Hinton Blewett Parish Council

Hook Lane

Inspection Ref: 1532863

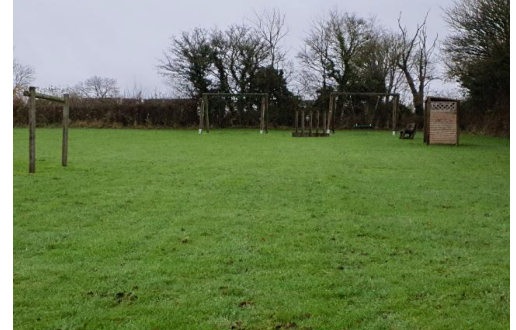
Item: Site General
Manufacturer: Not Applicable
Surface Type: N/A
Item Quantity: 1
Equipment Compliance: N/A
Surface Area Compliance: N/A

There is algae or moss on the surface of the items inspected - Clean and treat appropriately

There is strimmer / machinery damage apparent on the posts, this can penetrate the preservative applied to the timber and accelerate the rotting process - Monitor for any deterioration (rot) and replace as required

The timber elements have a number of splits/shakes or air cracks and this may affect the stability or allow water ingress which will accelerate the rotting process - Monitor to ensure the splits do not cross through fixing points of the structure and/or cause any instability

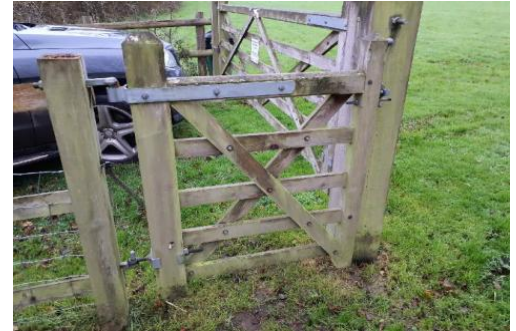
Item: Gate - Self Closing
Manufacturer: Not Identified
Surface Type: Grass
Item Quantity: 1
Equipment Compliance: N/A
Surface Area Compliance: N/A

There are openings that are less than 12mm that could trap or crush fingers - Where possible a 12mm gap should be maintained on both sides or between the gate leaves

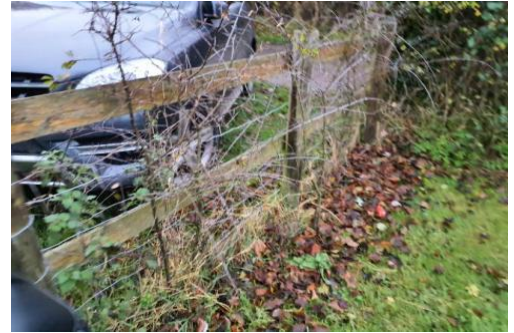
Item: Fence - Timber & Mesh Infill
Manufacturer: Not Identified
Surface Type: Grass
Item Quantity: 1
Equipment Compliance: N/A
Surface Area Compliance: N/A

There are areas or parts of the timber on the structure that have rotted - Replace all affected timbers

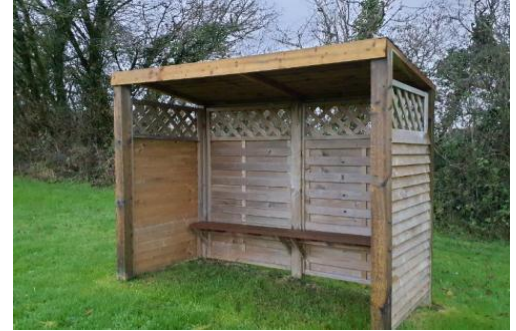
Item: Seating Area
Manufacturer: Not Identified
Surface Type: Grass
Item Quantity: 1
Equipment Compliance: N/A
Surface Area Compliance: N/A

Parts of the timber are rough or splintered - Remove all rough or sharp edges

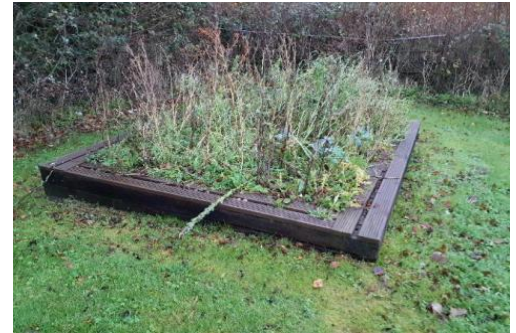
Item: Planting Area
Manufacturer: Not Identified
Surface Type: Grass
Item Quantity: 1
Equipment Compliance: N/A
Surface Area Compliance: N/A

The foliage is overgrown - Cut back and maintain

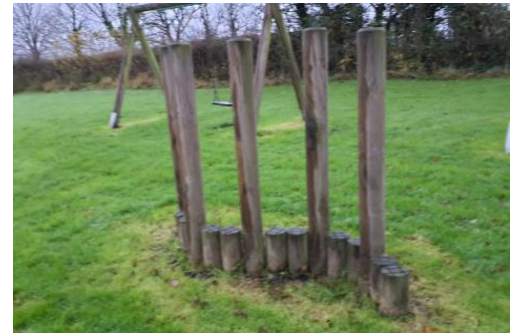
Item: Log Weave
Manufacturer: GL Jones
Surface Type: Grass Matrix Tiles
Item Quantity: 1
Equipment Compliance: Yes
Surface Area Compliance: N/A

There is some evidence of rot in the timber - Monitor for any further deterioration and replace as required

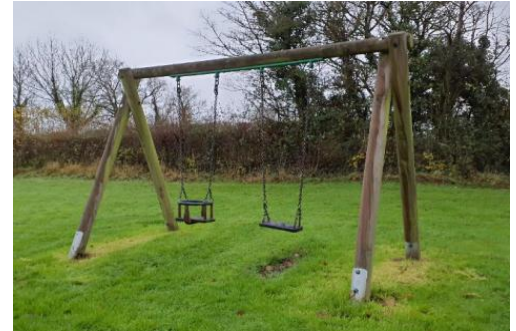
Item: 1 Bay 2 Seat Swing
Manufacturer: GL Jones
Surface Type: Grass Matrix Tiles
Item Quantity: 1
Equipment Compliance: No
Surface Area Compliance: Yes

There is/are bolt cap covers missing or damaged on the item - Replace missing or damaged bolt cap covers

The chain openings are in excess of the 8.6mm as recommended by BS EN 1176 - Monitor - No remedial work recommended

There is some notable evidence of chain wear - Monitor for any further deterioration and replace when 40% worn

The inspector has some concerns about the internal condition of the timber cross bar (timber discolouration may indicate internal rot) and was unable to verify the structural integrity without further testing. We recommend a Resi-PD survey to establish the condition of the timber at it's core. - Contact the Play Inspection Company office for further information

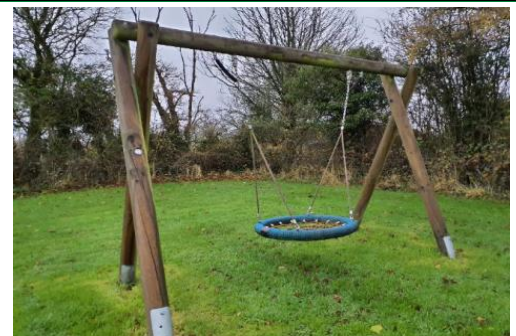
Item: Basket Swing - Type 1
Manufacturer: GL Jones
Surface Type: Grass Matrix Tiles
Item Quantity: 1
Equipment Compliance: Yes
Surface Area Compliance: Yes

There is/are bolt cap covers missing or damaged on the item - Replace missing or damaged bolt cap covers

The ropes/nets are worn/damaged in places - Monitor for any further deterioration and repair or replace as required

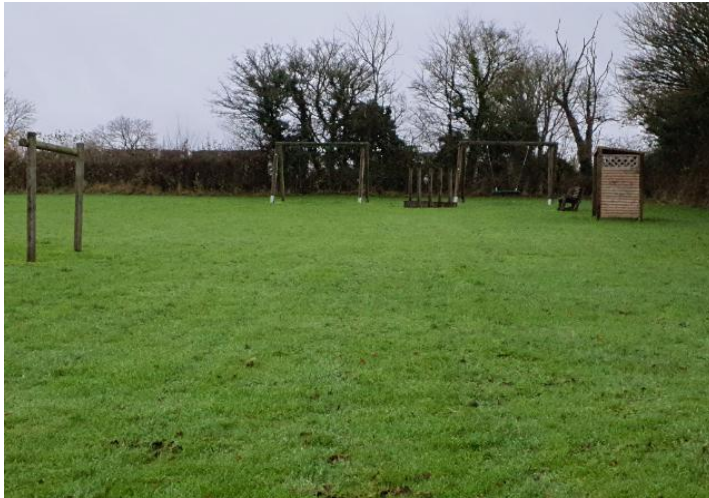
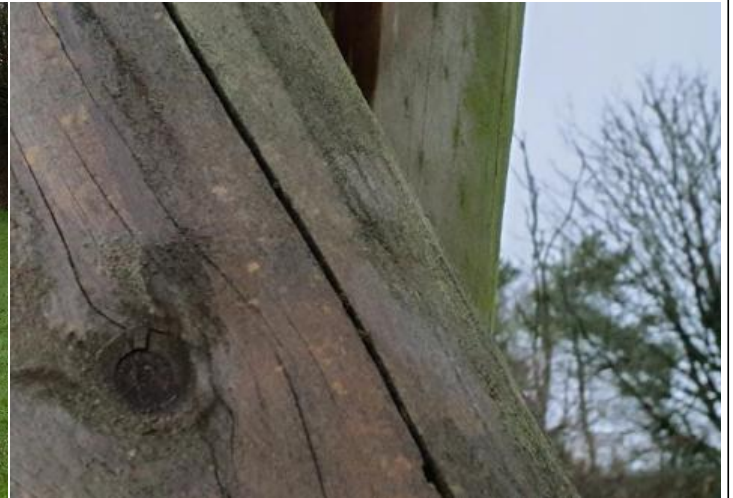
Item: Ancillary Items - Site General
Manufacturer: Not Applicable

Finding: The timber elements have a number of splits/shakes or air cracks and this may affect the stability or allow water ingress which will accelerate the rotting process

Action: Monitor to ensure the splits do not cross through fixing points of the structure and/or cause any instability

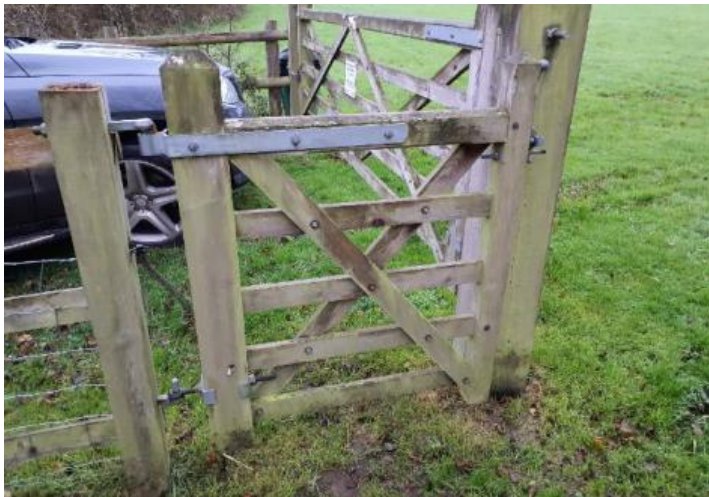
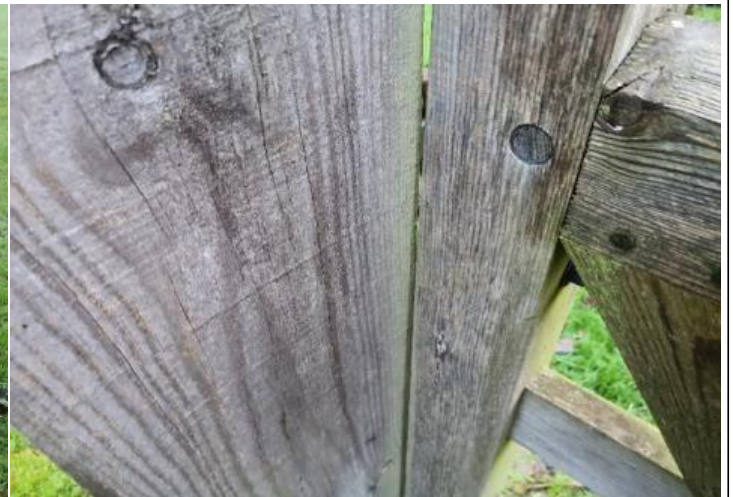
Item: Gates - Gate - Self Closing
Manufacturer: Not Identified

Finding: There are openings that are less than 12mm that could trap or crush fingers

Action: Where possible a 12mm gap should be maintained on both sides or between the gate leaves

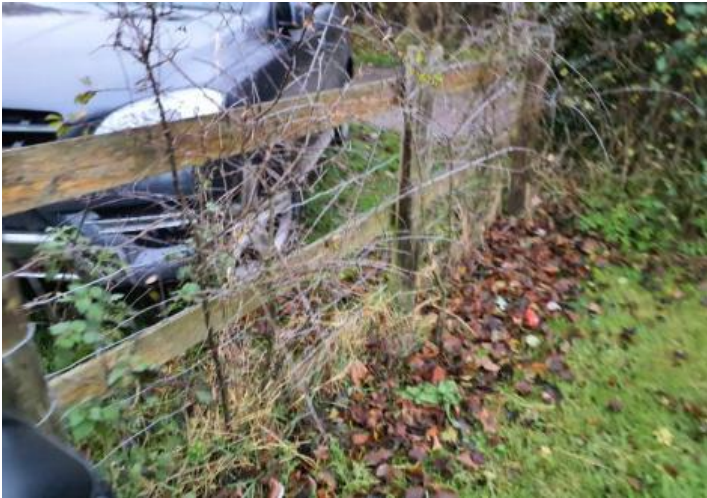
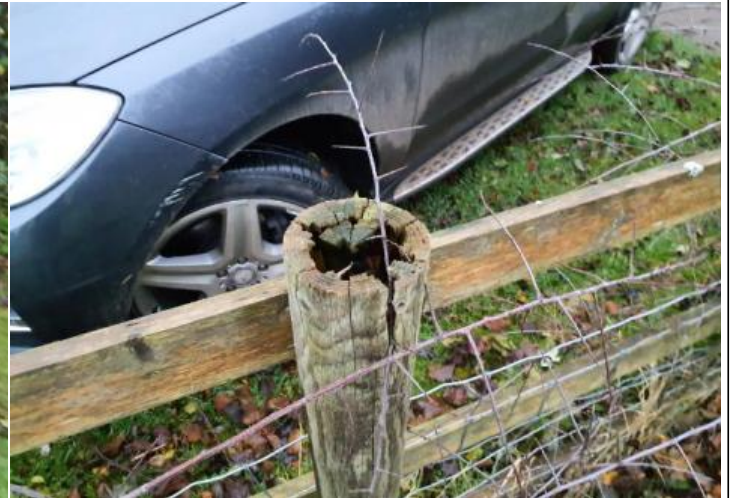
Item: Fences - Fence - Timber & Mesh Infill
Manufacturer: Not Identified

Finding: There are areas or parts of the timber on the structure that have rotted

Action: Replace all affected timbers

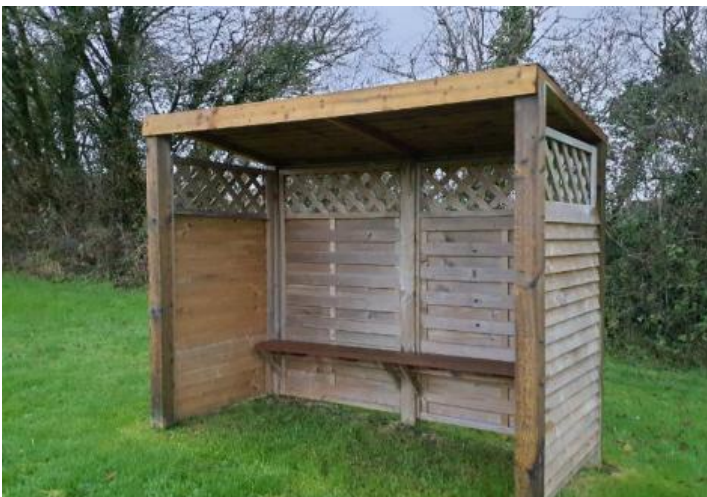
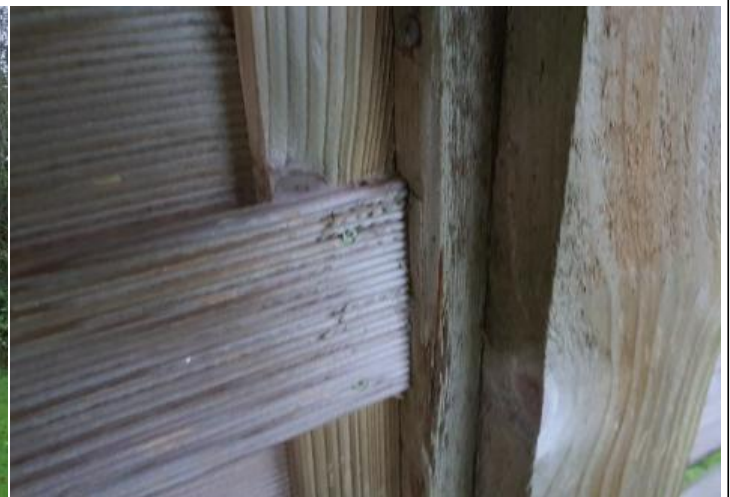
Item: Ancillary Items - Seating Area
Manufacturer: Not Identified

Finding: Parts of the timber are rough or splintered

Action: Remove all rough or sharp edges

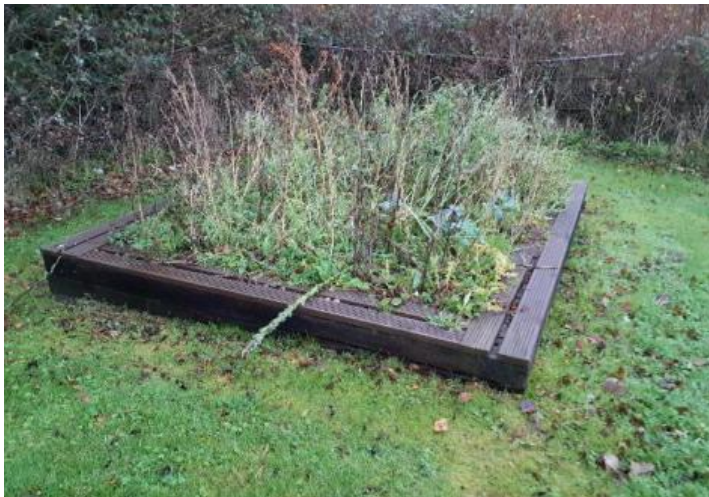
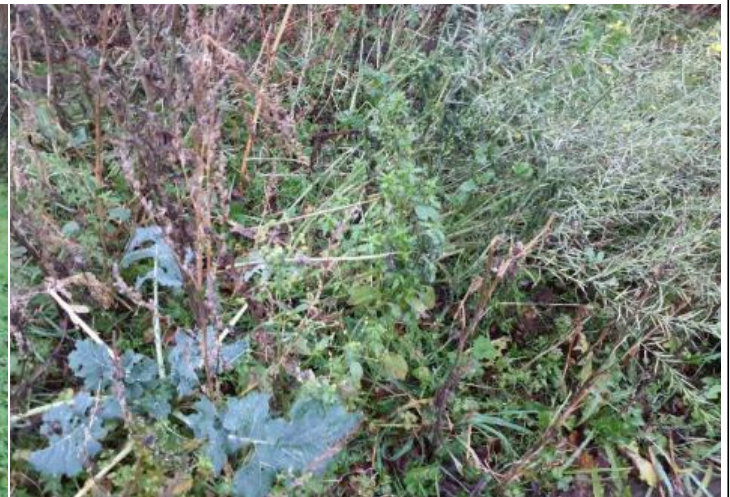
Item: Ancillary Items - Planting Area
Manufacturer: Not Identified
Risk Level: L - Low Risk
Surface: Grass

Finding: The foliage is overgrown
Action: Cut back and maintain

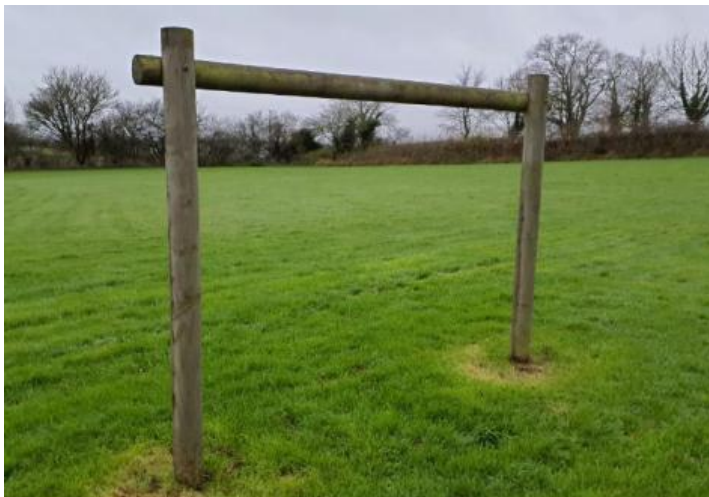
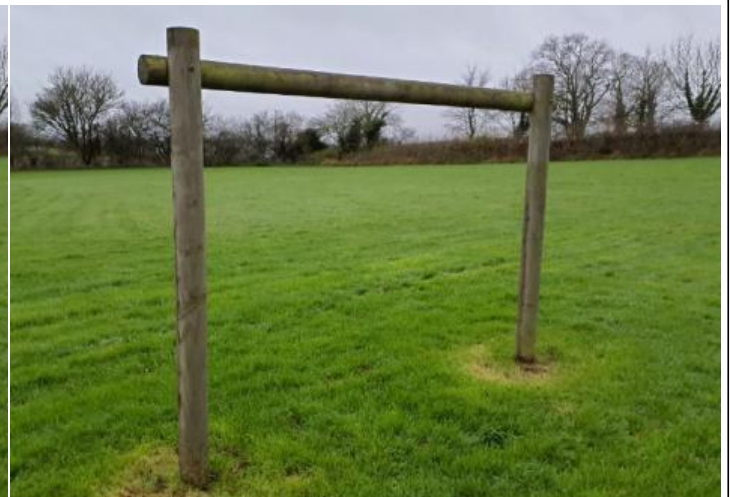
Item: Multi Use Games Area - Football Goal
Manufacturer: Not Identified
Risk Level: N - Risk Assessment not Undertaken
Surface: Grass

Finding: NB: We have undertaken a maintenance inspection only of the football goal(s); full load testing falls outside the scope of our inspection.
Action: Implement load testing as required

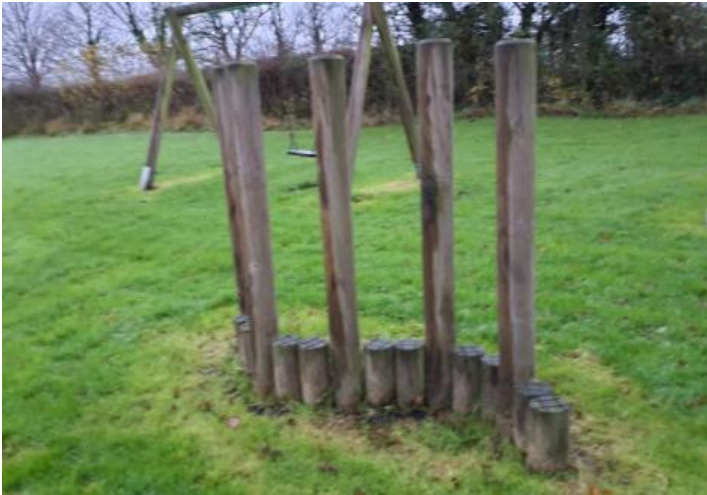
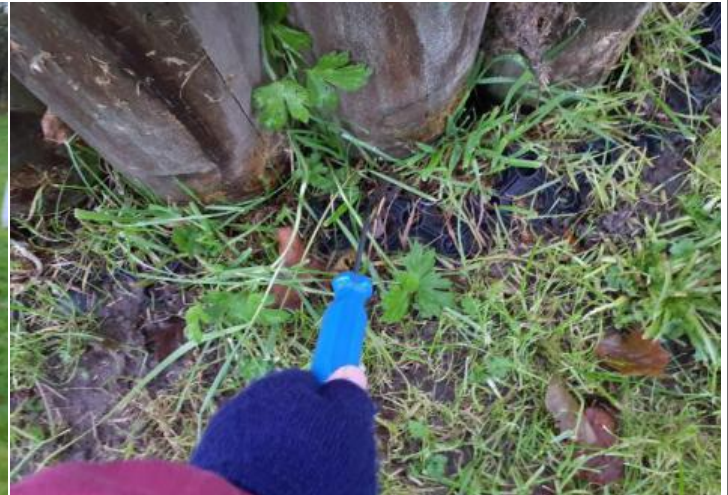
Item: Activity Equipment - Log Weave
Manufacturer: GL Jones
Risk Level: L - Low Risk
Surface: Grass Matrix Tiles

Finding: There is some evidence of rot in the timber
Action: Monitor for any further deterioration and replace as required

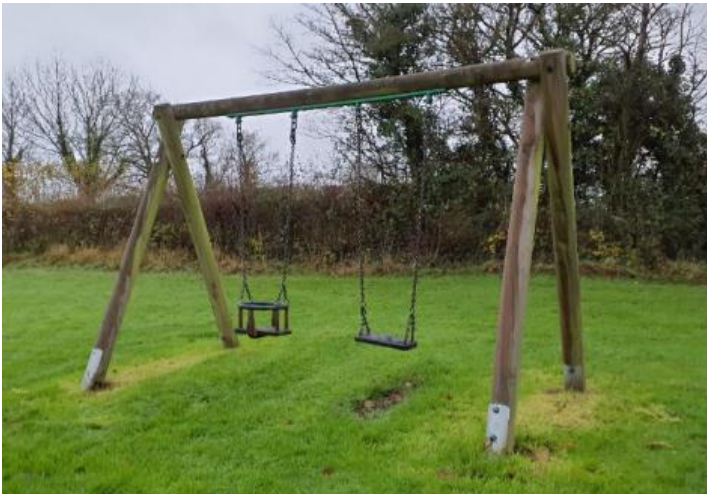
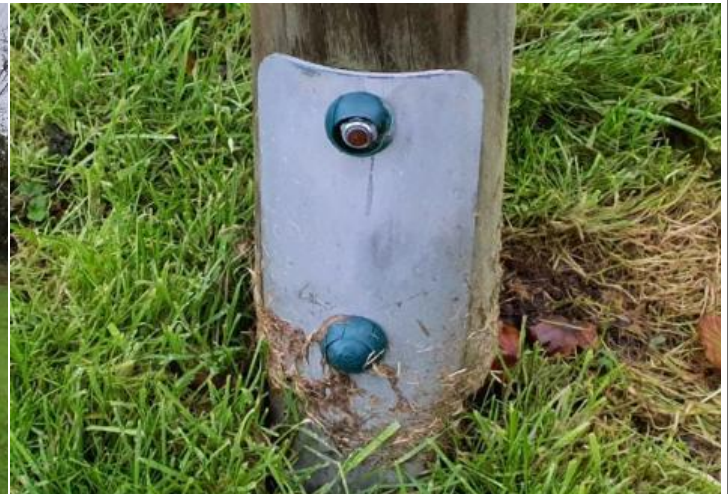
Item: Swings - 1 Bay 2 Seat Swing
Manufacturer: GL Jones
Risk Level: V - Very Low Risk
Surface: Grass Matrix Tiles

Finding: There is/are bolt cap covers missing or damaged on the item
Action: Replace missing or damaged bolt cap covers

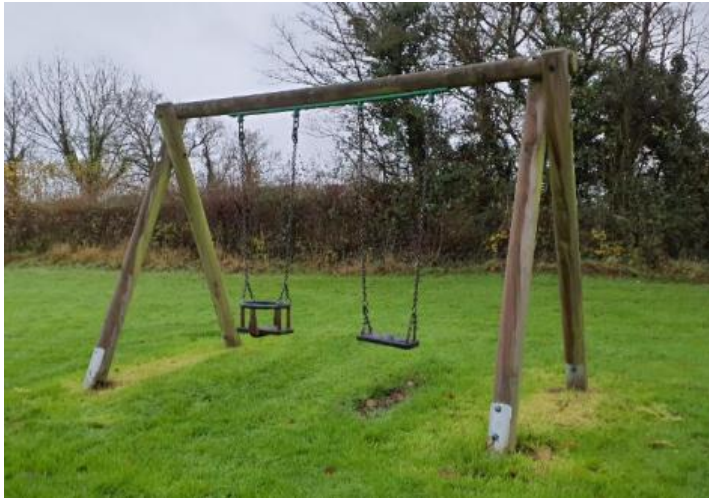
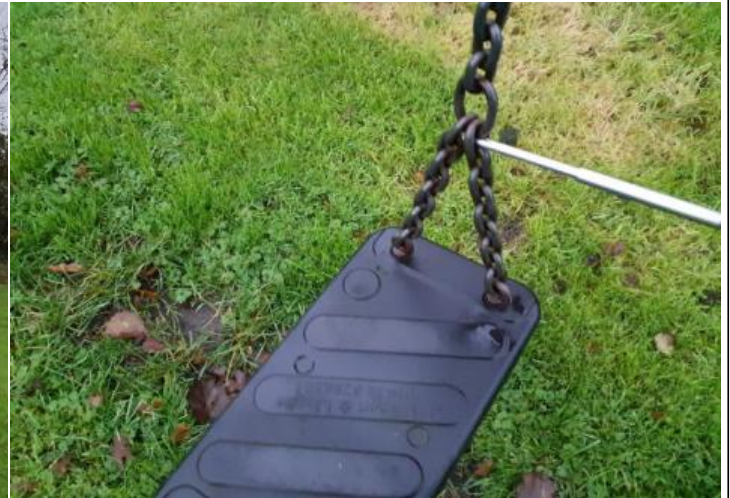
Item: Swings - 1 Bay 2 Seat Swing
Manufacturer: GL Jones

Finding: The chain openings are in excess of the 8.6mm as recommended by BS EN 1176 **Action:** Monitor - No remedial work recommended

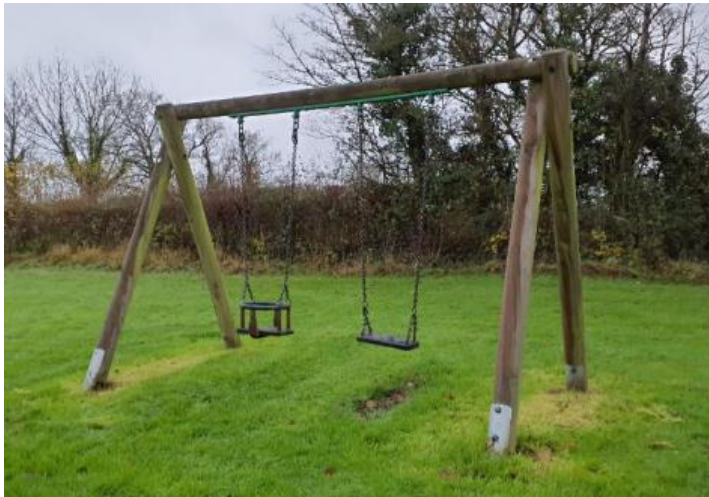
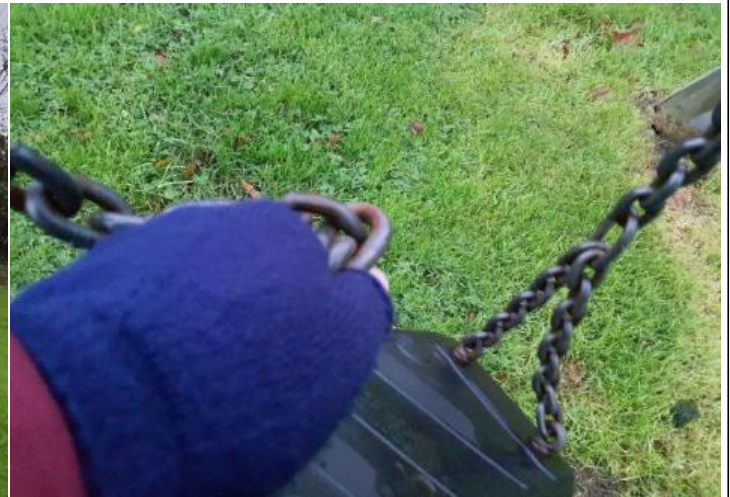
Item: Swings - 1 Bay 2 Seat Swing
Manufacturer: GL Jones

Finding: There is some notable evidence of chain wear **Action:** Monitor for any further deterioration and replace when 40% worn

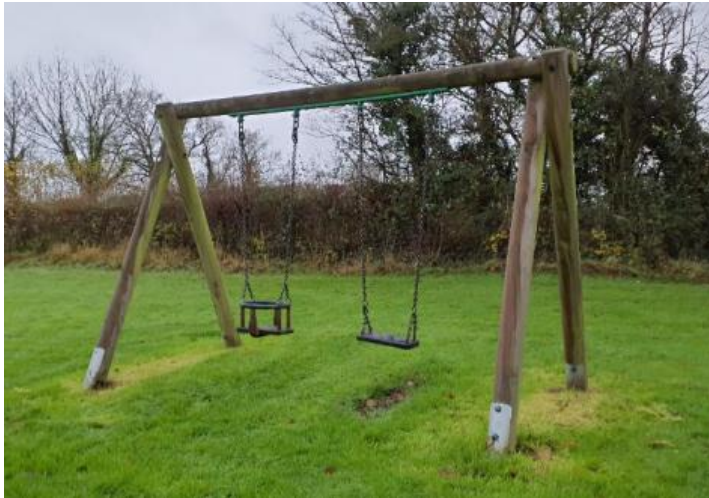
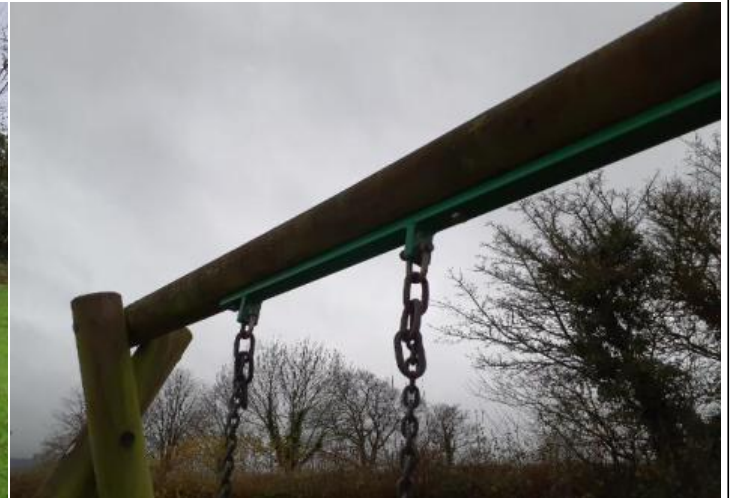
Item:	Swings - 1 Bay 2 Seat Swing	Risk Level:	N - Risk Assessment not Undertaken
Manufacturer:	GL Jones	Surface:	Grass Matrix Tiles

Finding: The inspector has some concerns about the internal condition of the timber cross bar (timber discolouration may indicate internal rot) and was unable to verify the structural integrity without further testing. We recommend a Resi-PD survey to establish the condition of the timber at it's core.

Action: Contact the Play Inspection Company office for further information

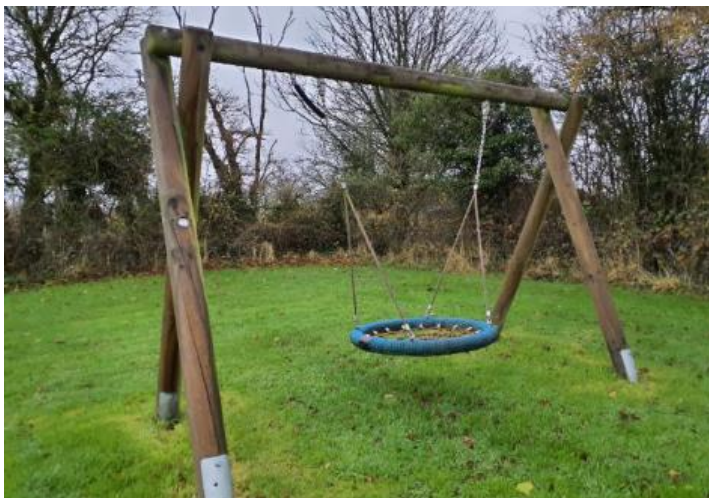
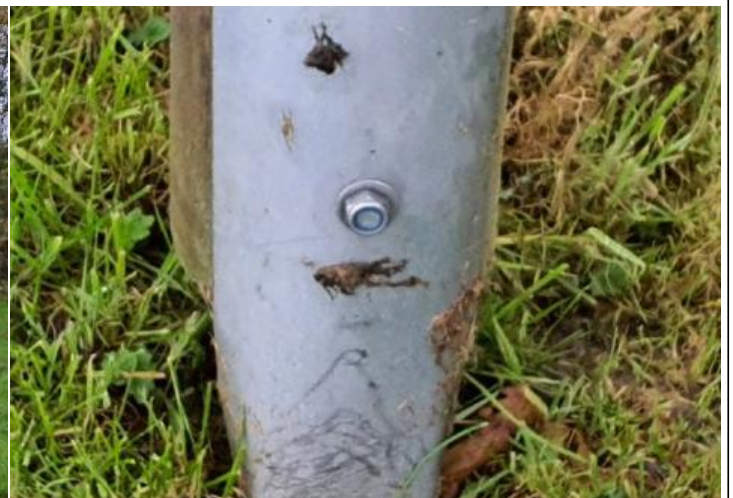
Item:	Swings - Basket Swing - Type 1	Risk Level:	V - Very Low Risk
Manufacturer:	GL Jones	Surface:	Grass Matrix Tiles

Finding: There is/are bolt cap covers missing or damaged on the item

Action: Replace missing or damaged bolt cap covers

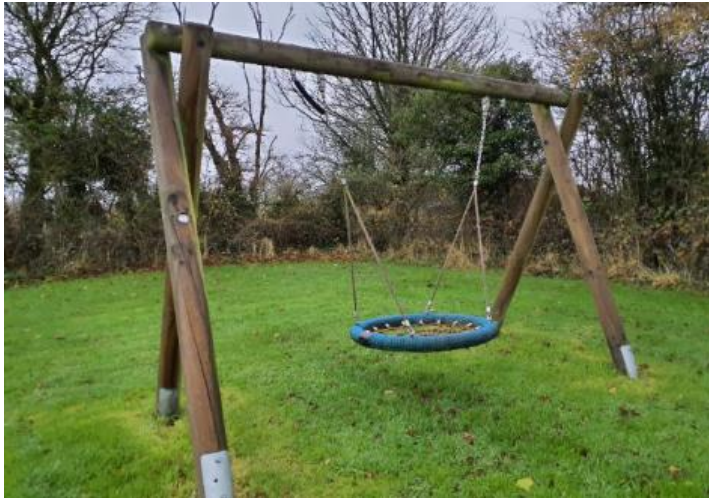
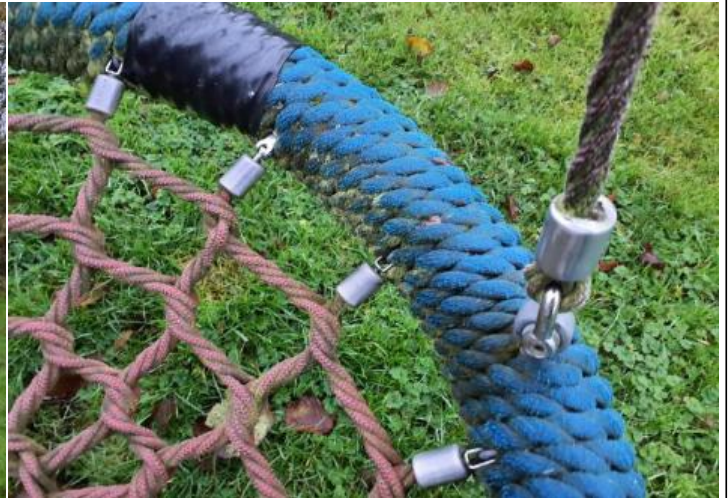
Item: Swings - Basket Swing - Type 1
Manufacturer: GL Jones

Finding: The ropes/nets are worn/damaged in places

Action: Monitor for any further deterioration and repair or replace as required
