On Site Resistograph Testing

Site Name

Brief

Undertake on site resistograph testing on five items of timber play equipment.

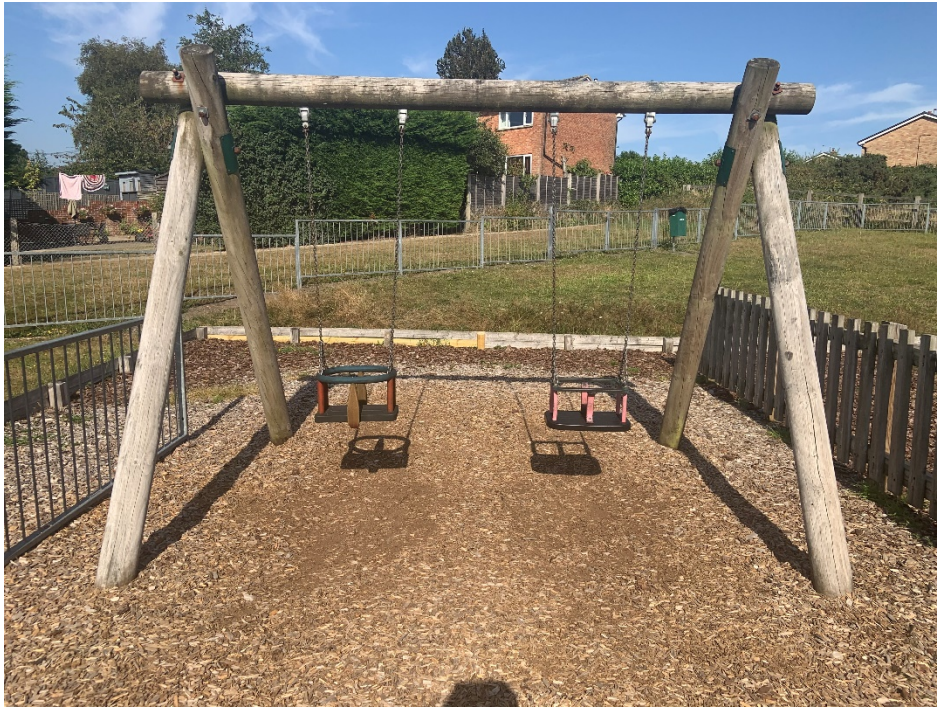
Item 1 Overview Cradle Seat Swing

Installation Date: Not Known
Surface Type: Woodchip

The item is supported by four timber posts and one timber crossbar each requiring testing, the remainder of the structure would not normally fall within the scope of testing.

Severe decay was identified in Post 3. Also refer to Annual Inspection Report.

The test results showed evidence of the onset of decay in Post 4 and Crossbar 1, no immediate action is required other than to monitor the condition of these timbers. The initial inspection identified severe decay in Post 3, replacement of this post is recommended with a degree of urgency.

Onset of Decay – Post 4 & Crossbar 1 (Monitor)

Severe Decay – Post 3 (Replace)

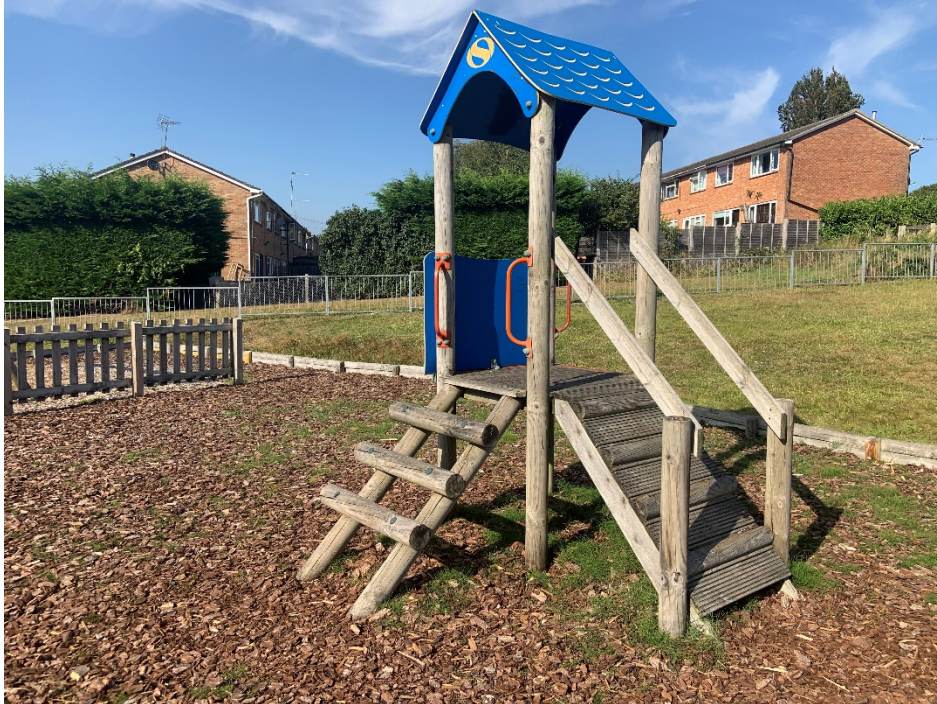
Item 2 Overview Multiplay Unit

Installation Date: Not Known
Surface Type: Bark Mulch

The item is supported by four primary timber posts and four secondary timber posts supporting the access/egress points each requiring testing, the remainder of the structure would not normally fall within the scope of testing.

Severe decay was identified in Posts 2, 4 and 7. Moderate decay was identified in Posts 1 and 3. Also refer to Annual Inspection Report.

The test results showed evidence of the onset of decay in Post 5, no immediate action is required other than to monitor the condition of this timber. The initial inspection identified moderate decay in Posts 1 & 3, the test results also identified the moderate rot in Post 1, replacement of these posts is recommended with a degree of urgency. The initial inspection also identified severe decay in Posts 2, 4 & 7, replacement of these posts is recommended with a degree of urgency.

Onset of Decay – Post 5 (Monitor)

Moderate Decay – Posts 1 and 3 (Replace)

Severe Decay – Posts 2, 4 and 7 (Replace)

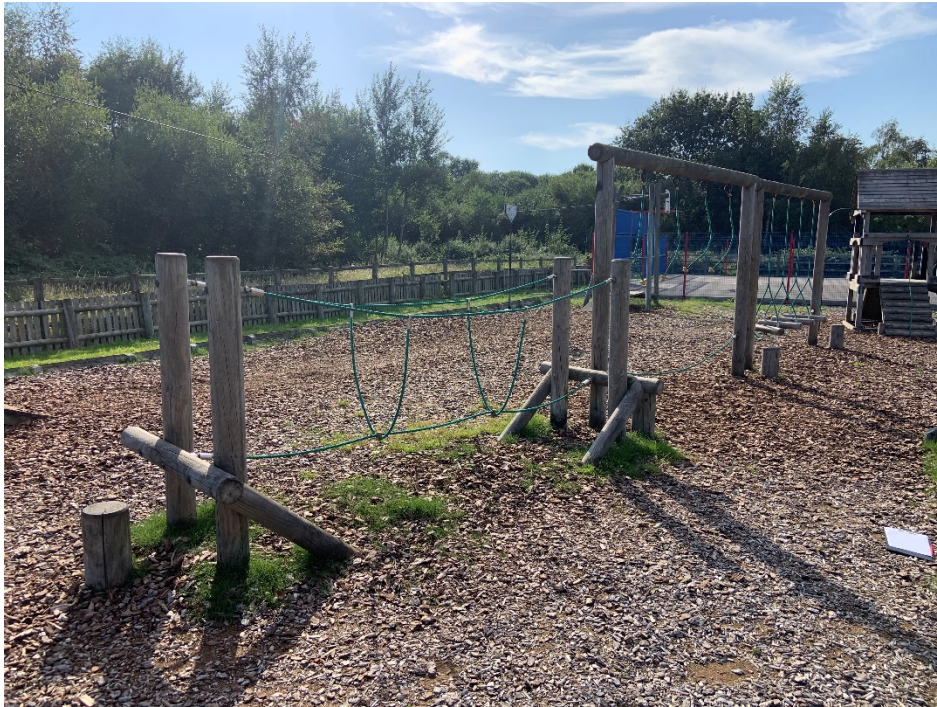
Item 3 Overview Activity Trail

Installation Date: Not Known
Surface Type: Bark Mulch

The item is supported by eight primary timber posts, four secondary timber posts and two timber crossbars each requiring testing, the remainder of the structure would not normally fall within the scope of testing.

Severe decay was identified in all four secondary timber posts (1, 6, 9, 12) and in Post 10. Evidence of minor decay was apparent in some other posts. Also refer to Annual Inspection Report.

The test results showed no evidence of decay within the timbers. The initial inspection identified severe decay in Posts 1, 6, 9, & 12, replacement of these posts is recommended. The initial inspection also identified severe decay in Post 10, urgent replacement of this post is recommended.

Severe Decay – Posts 1, 6, 9 and 12 (Replace)

Severe Decay – Post 10 (Urgent Replacement – isolate equipment until replaced)

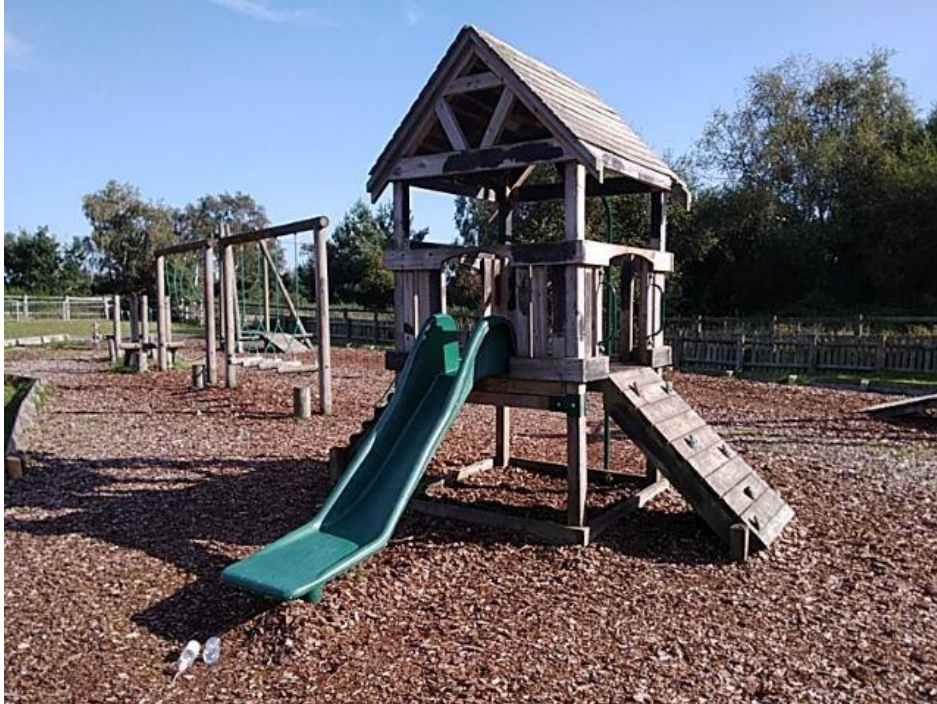
Item 4 Overview Multiplay Unit

Installation Date: Not Known
Surface Type: Bark Mulch

The item is supported by four primary timber posts and four secondary timber posts supporting the access/egress points each requiring testing, the remainder of the structure would not normally fall within the scope of testing.

Severe decay was identified in Posts 2 and 8. Moderate decay was identified in Posts 5 and 6. Also refer to Annual Inspection Report.

The test results identified moderate decay in Posts 3, 4, 5 and 7, the test results also identified severe decay in Post 6. The initial inspection identified severe decay in Posts 2 & 8, replacement of these posts is recommended.

Moderate Decay – Posts 3, 4, 5, & 7 (Replace)

Severe Decay – Posts 2, 6 & 8 (Replace)

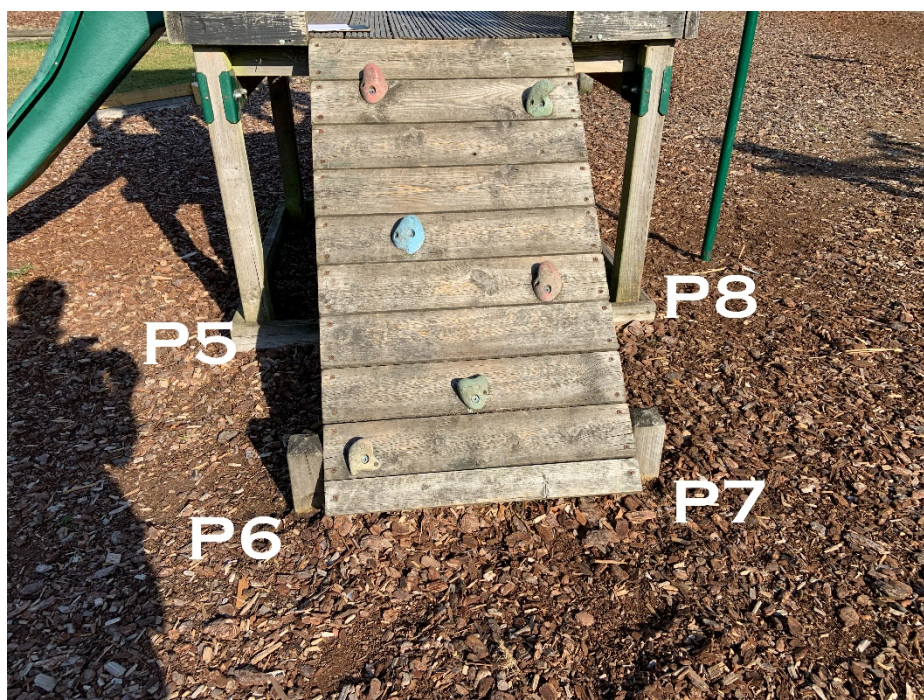
Item 4 Timber Identification Multiplay Unit

Standard Methodology was adopted.

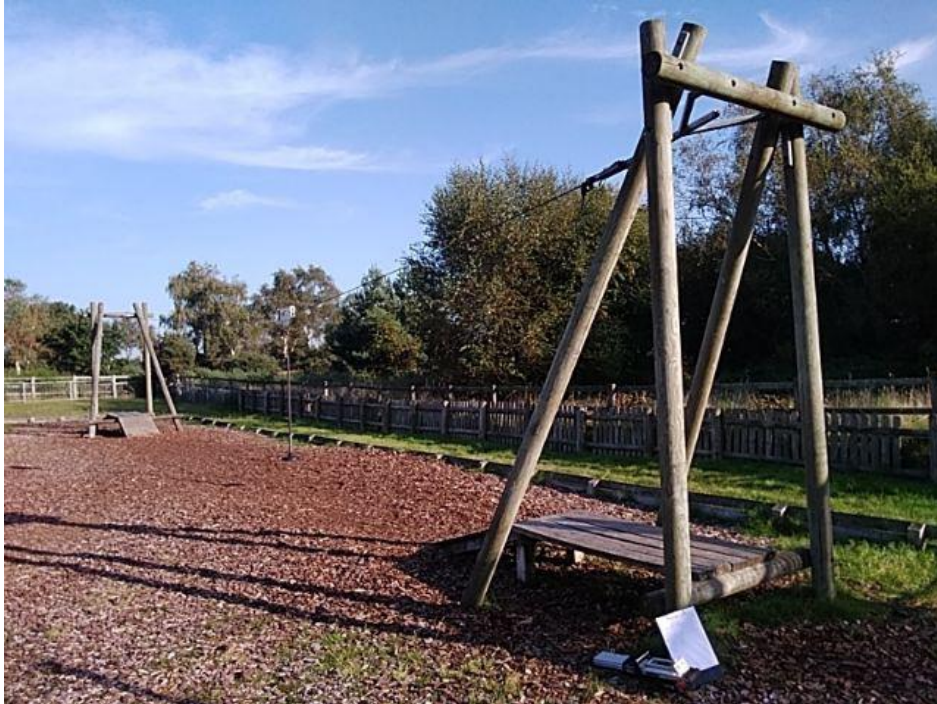
Item 5 Overview Cableway

Installation Date: Not Known
Surface Type: Bark Mulch

The item is supported by eight timber posts each requiring testing, the remainder of the structure would not normally fall within the scope of testing.

Severe decay was identified in Post 5. Moderate decay was identified in Post 6. Also refer to Annual Inspection Report.

The test results showed evidence of the onset of decay in Post 4, no immediate action is required other than to monitor the condition of this timber. The initial inspection identified moderate decay in Post 6, the test results also identified the moderate rot in Post 6, replacement of this post is recommended with a degree of urgency. The initial inspection also identified severe decay in Post 5, urgent replacement of this post is recommended.

Moderate Decay – Post 6 (Replace)

Severe Decay – Post 5 (Urgent Replacement – isolate equipment until replaced)

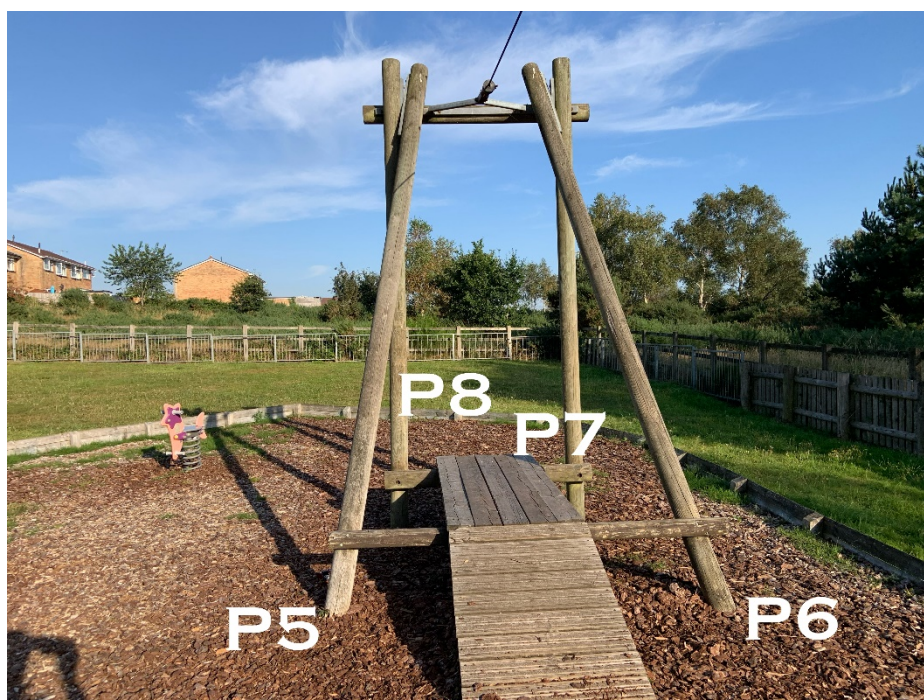
Item 5 Timber Identification Cableway

Standard methodology was adopted.
