Annual Inspection

Hinton Blewett Parish Council

Hook Lane

Inspection Ref: 1532863

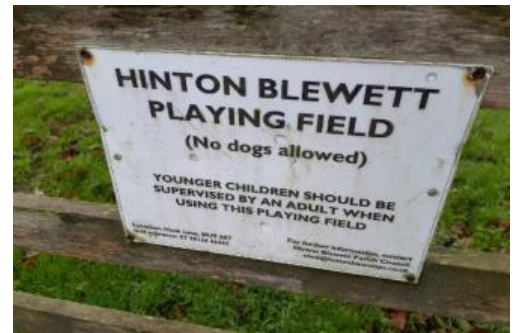
Item: Sign
Manufacturer: Not Identified
Surface Type: N/A
Item Quantity: 1
Equipment Compliance: N/A
Surface Area Compliance: N/A

This item is satisfactory - no work required -

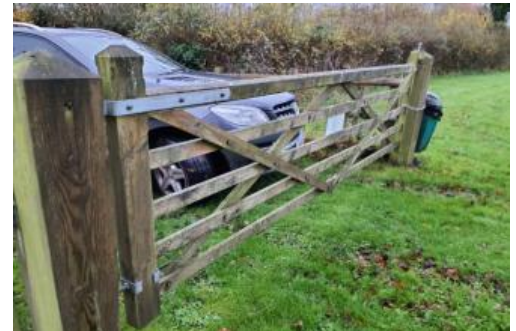
Item: Gate - Maintenance
Manufacturer: Not Identified
Surface Type: Grass
Item Quantity: 1
Equipment Compliance: N/A
Surface Area Compliance: N/A

i 4 - Very Low Risk

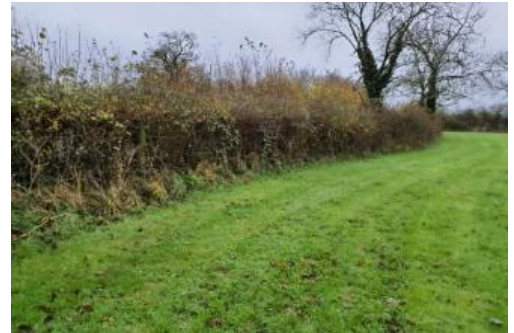
Item: Hedge
Manufacturer: Not Applicable
Surface Type: Grass
Item Quantity: 1
Equipment Compliance: N/A
Surface Area Compliance: N/A

This item is satisfactory - no work required -

i 4 - Very Low Risk

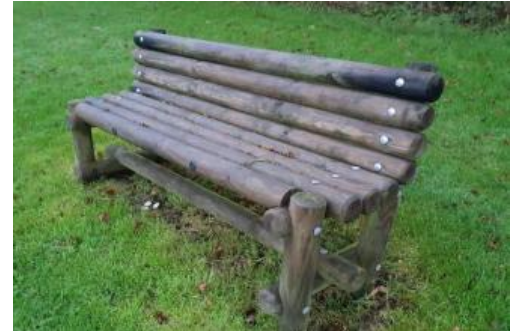
Item: Bench
Manufacturer: Not Identified
Surface Type: Grass
Item Quantity: 1
Equipment Compliance: N/A
Surface Area Compliance: N/A

i 4 - Very Low Risk

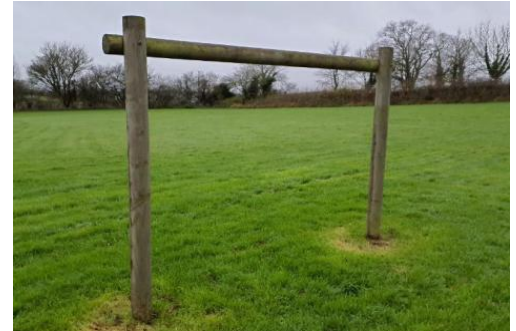
Item: Football Goal
Manufacturer: Not Identified
Surface Type: Grass
Item Quantity: 1
Equipment Compliance: N/A
Surface Area Compliance: N/A

i 0 - Risk Assessment not Undertaken
